## Appendix 5: Faultline Study – Tonkin and Taylor

## **Te Rangihaeata / Manor Park Development Wellington Fault Investigation Report**

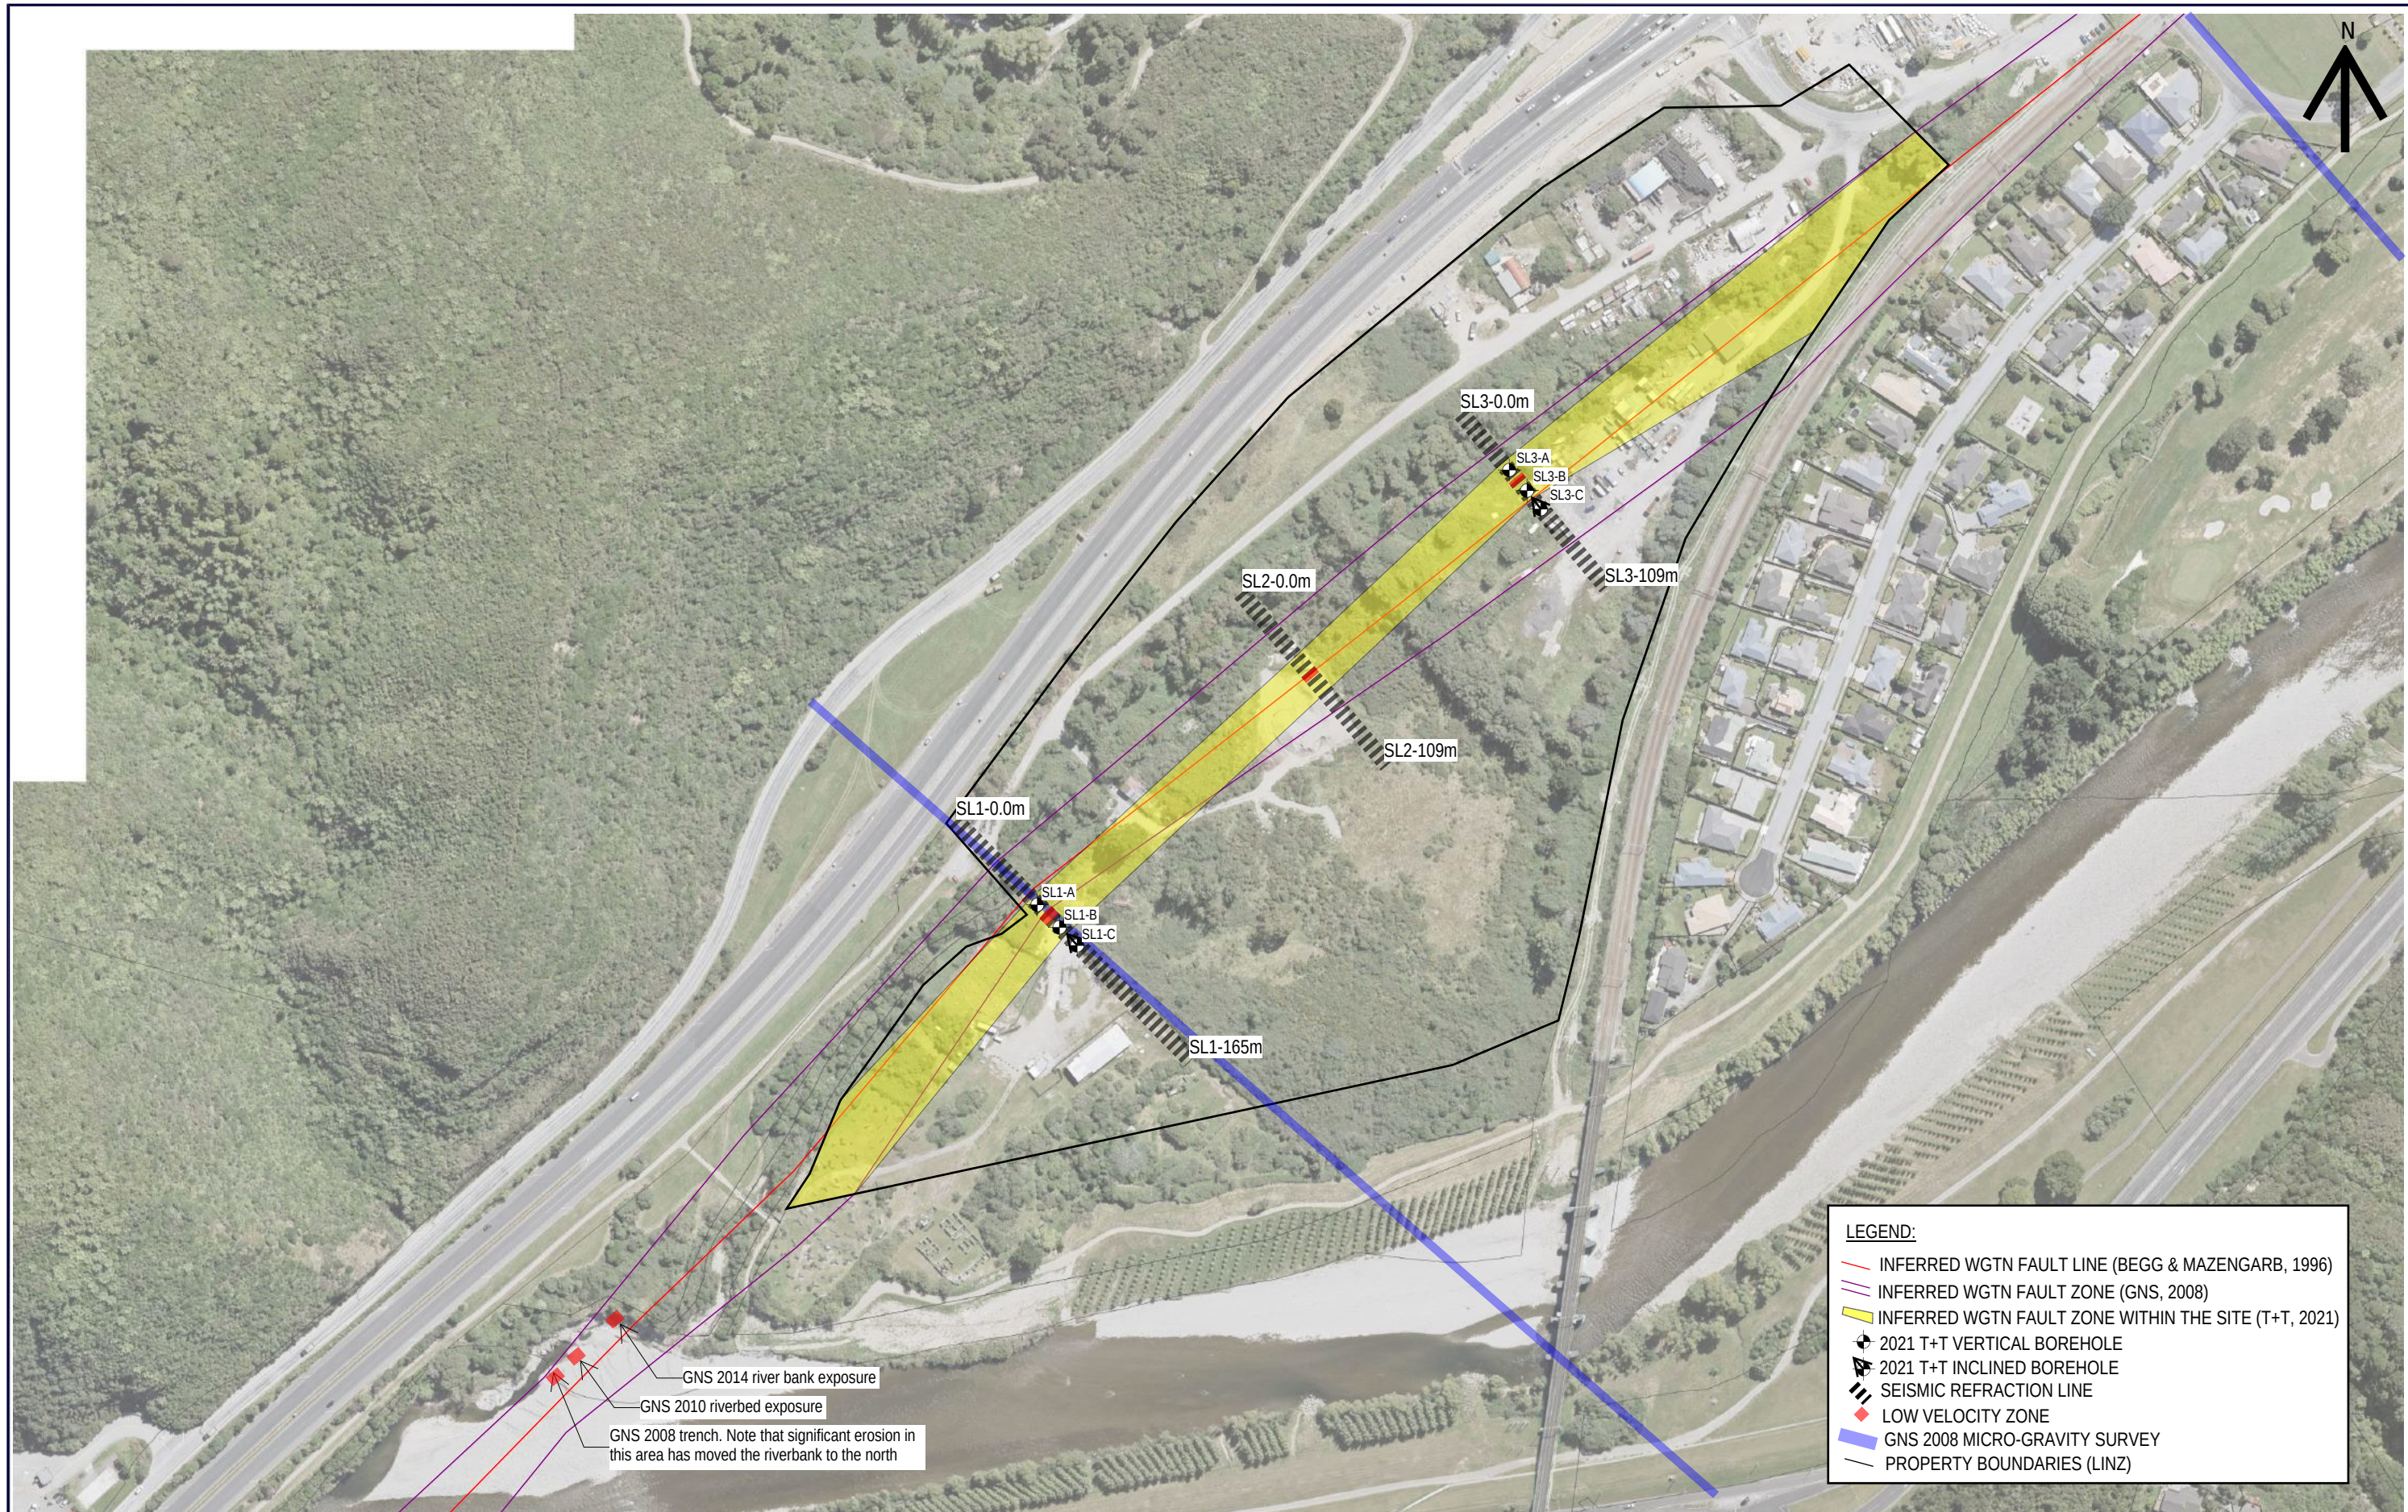
- **Figure A1 Wellington Fault investigation location plan**
- **Figure A2 Cross Section SL-1**
- **Figure A3 Cross Section SL-3**

In Begg & Mazengrab (1996)<sup>1</sup>, the Wellington Fault through the Manor Park site was mapped as 'concealed' due to an overburden of alluvial deposits, and therefore the precise location was not well understood. This lineament through the site is based on interpretation of the geomorphology and aligns with surface exposure of the fault to the northeast and southwest of the site. This approximate location is shown in Figure A1, Appendix A.

Beetham et. al. (2008)<sup>2</sup> carried out fault investigations in the vicinity of the Manor Park site to guide the planning and design of the major interchange between SH58 and SH2. The investigations completed included a fault trench immediately to the south of the site, and three micro-gravity survey profiles (one of which is located through the site, and two to the northeast). The investigation constrained the likely location of the Wellington fault to a narrow (35 to 60 m wide) zone through the site as shown in Figure A1, Appendix A. Two of the three survey profiles are also shown in Figure A1.

Observations of the Wellington Fault within the Hutt River bed and on the western (true right) riverbank were made in 2010 and 2014<sup>3</sup>, and have recently been presented to T+T by Van Dissen (2020). These observations were made immediately to the south of the Manor Park site as shown in Figure A1, Appendix A.

When extrapolating the low velocity zones between the seismic refraction surveys and the exposures observed by Van Dissen to the south of the site, the inferred alignment of the fault is relatively consistent through the site (azimuth ~048°).

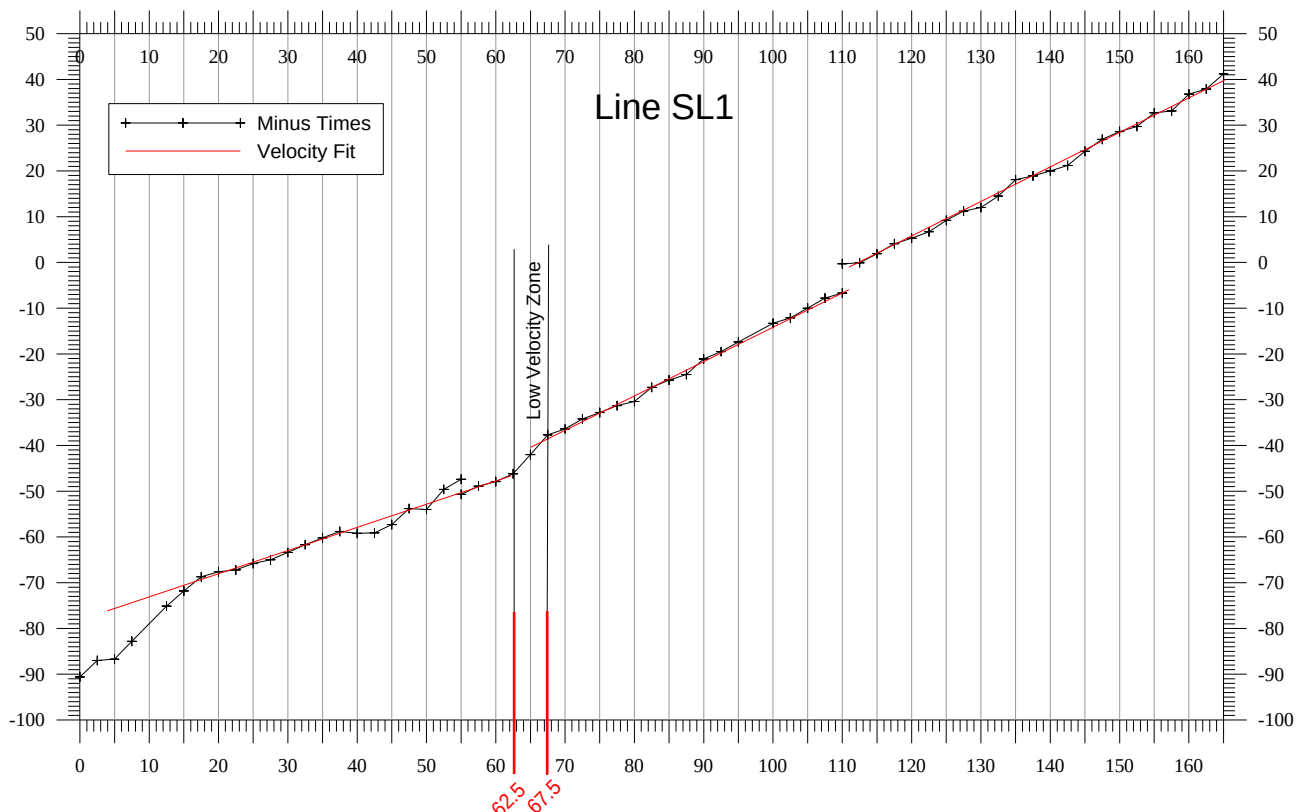
A surface layer of 300m/s is present along all of the line and an intermediate layer of 900m/s is also present. The rock layer has a velocity of 2750m/s along the eastern end of the line and 3900m/s at the western end of the line.

The plot below shows the times for the end shots at peg zero subtracted from the times for the offset shot at the far end of the line. The slope of the line is related to the velocity of the rock where the refraction is from the rock. A low velocity zone with a loss of 4 milliseconds was found between pegs 62.5 and 67.5m.

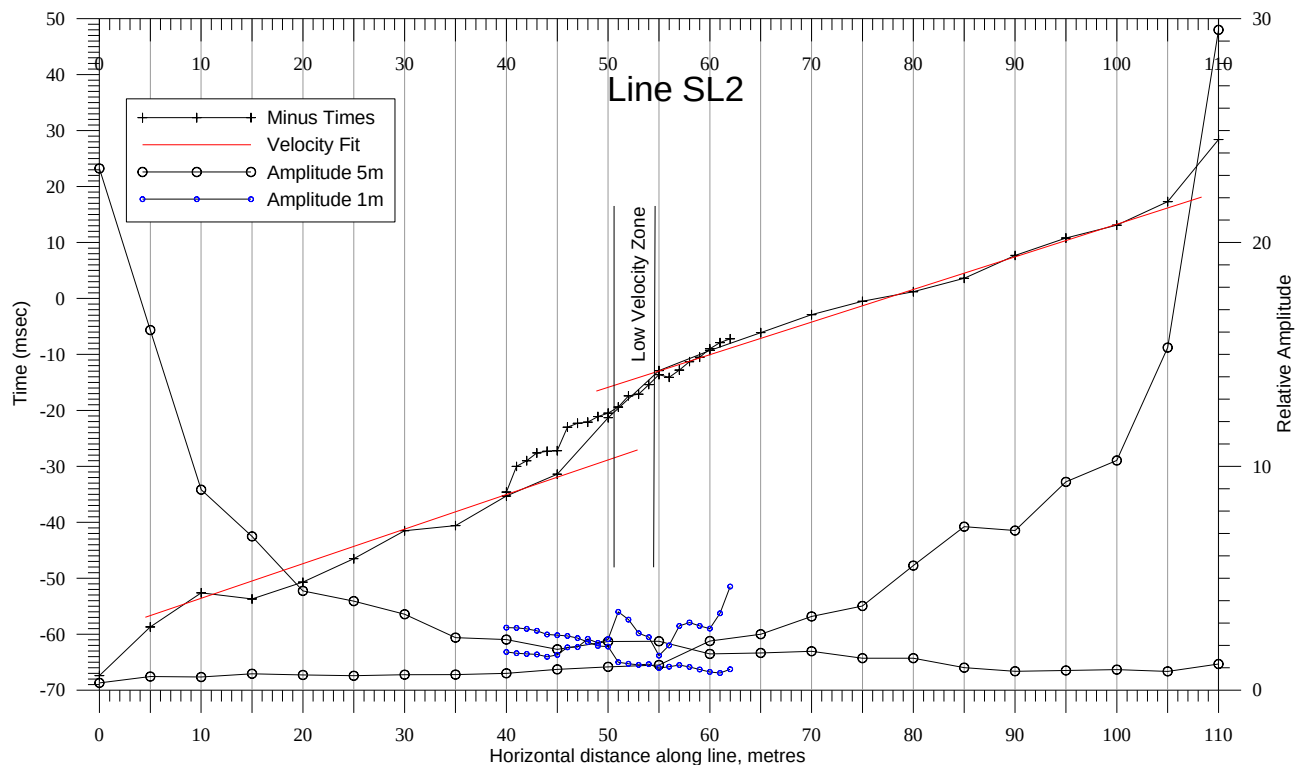
## 4.2 Seismic Line 2

The plot below shows the times for the offset shots from peg zero subtracted from the times for the offset shot at the far end of the line. The slope of the line is related to the velocity of the rock where the refraction is from the rock. A low velocity zone with a loss of 6 milliseconds was found between pegs 45 and 55m. Additionally, the maximum amplitude of the signal at each geophone, for each offset shot is shown. The signal should be attenuated as it passes through the low velocity zone. The values of amplitude will be affected by background noise superimposed on the signal so may have some scatter in the values. The 1m spaced shot from the zero end of the shows a sudden step between 50 and 51m, with a relatively even attenuation either side.

Taking into account the velocity step and the amplitude changes the most likely position of the low velocity zone is between pegs 50 to 55m.

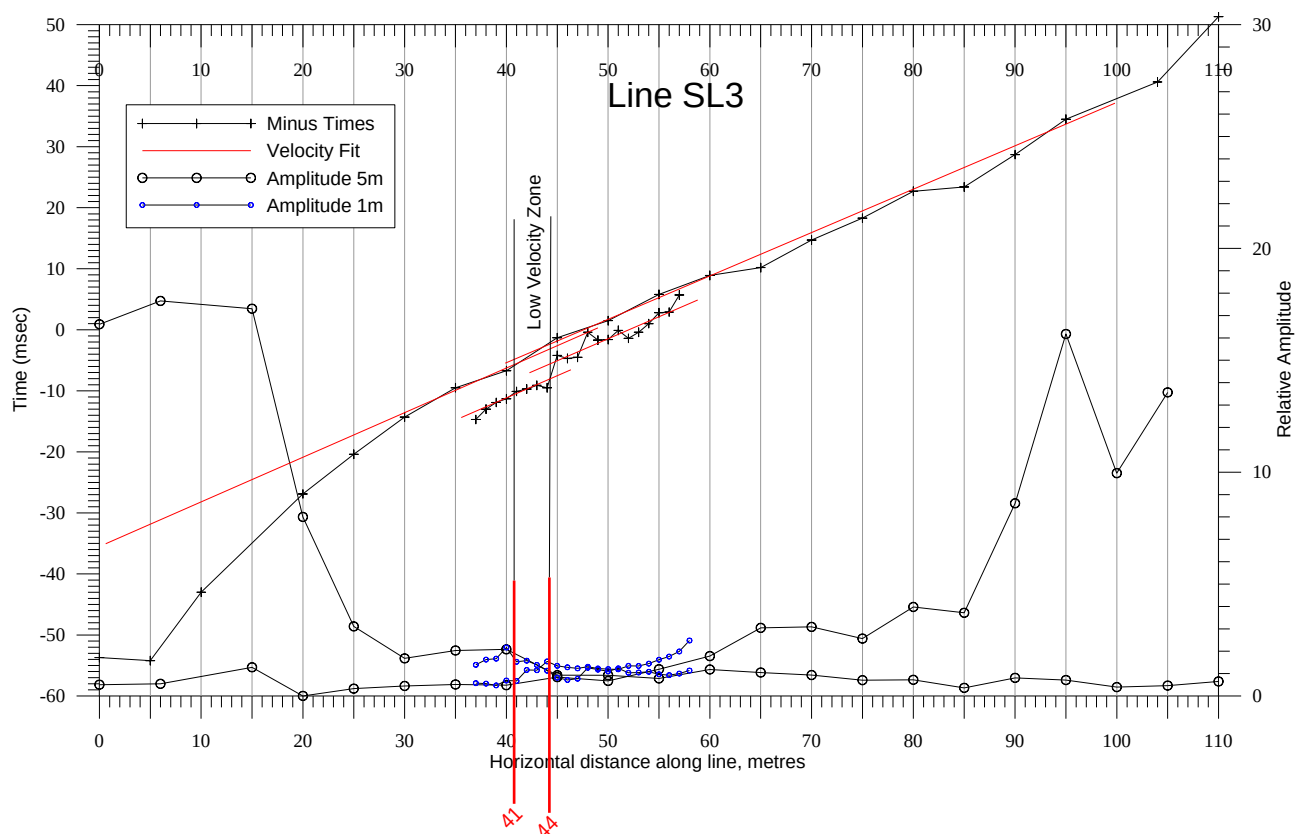
### 4.3 Seismic Line 3

A surface layer of 300m/s is present along all of the line and an intermediate layer of 600 to 800m/s is also present. The rock layer has a velocity of 2900m/s along the length of the line.

The plot below shows the times for the offset shots from peg zero subtracted from the times for the offset shot at the far end of the line. The slope of the line is related to the velocity of the rock where the refraction is from the rock. A low velocity zone with a loss less than 1 milliseconds was found between pegs 40 and 45m. Additionally the maximum amplitude of the signal at each geophone, for each offset shot is shown, as with line 2. Both of the 1m spaced shots and the 5m spaced offset from the zero end of the shows a step between 40 and 45m, which reinforces the small step seen on the velocity plot.
