## Geotechnical Investigation

14 Waiu Street

Wainuiomata

12.03.2021

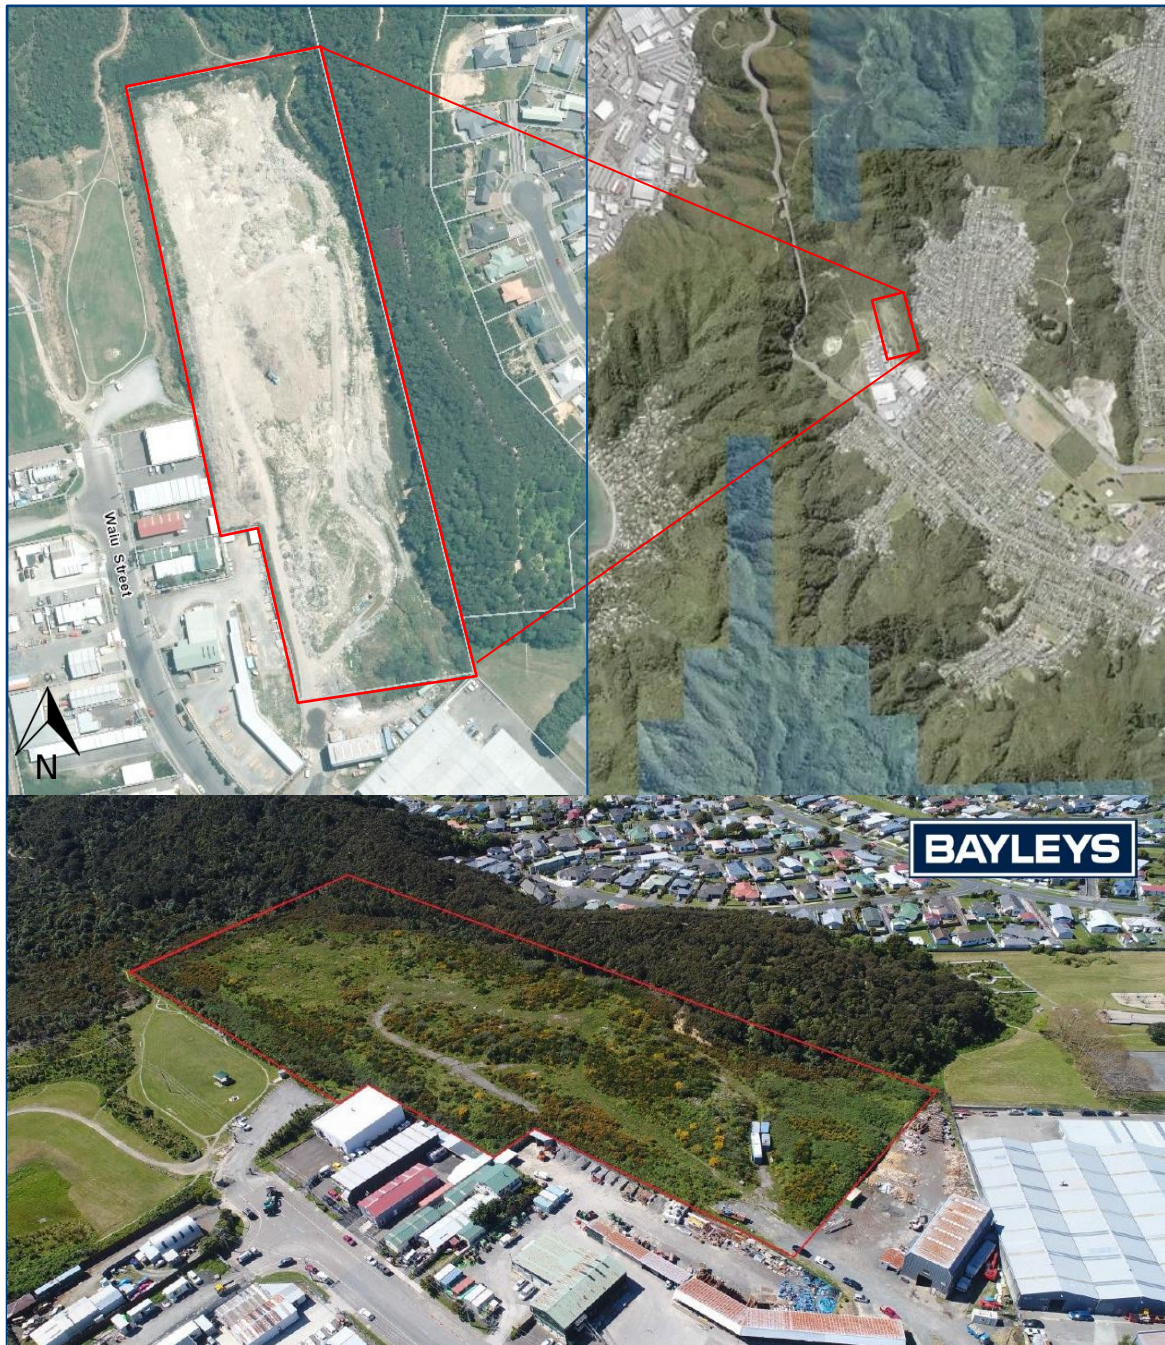
**Figure 1: Site Location Plan**

The site at 14 Waiu Street is located on a relatively flat site in an industrial area in Wainuiomata, Lower Hutt. The site is approximately 3.51 hectares and is elevated above the surrounding industrial properties to the west and the south. The site is lightly vegetated with gorse and shrubs. The site location is shown in Figure 1.

Images retrieved from Google Earth (top) and Bayleys (bottom)

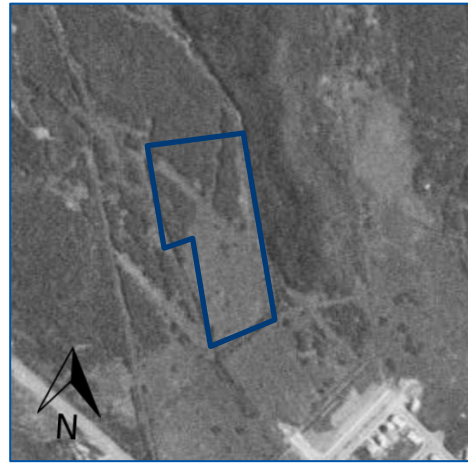
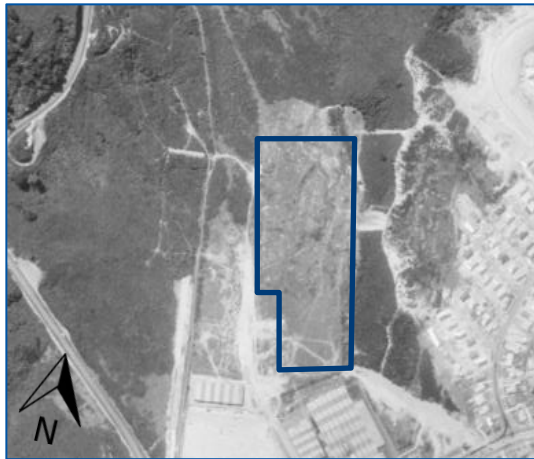
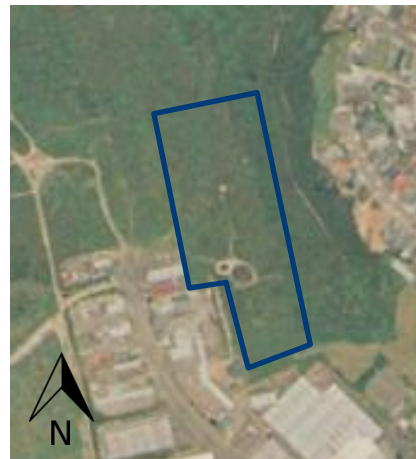
**Figure 3: Historical Photos**

We have reviewed historical aerial imagery of the site shown in Figure 3, available through Retrolens, and Google Earth with the earliest available photograph dated 1941. These photos were viewed under the context of identifying changes to morphology and use of the site, outlined below:

- Imagery dated 1941 and 1954 shows the site was mostly grassland with a small meandering stream present. A hedge can be seen passing through the site.
- Imagery dated 1972 shows a recently constructed road and residential properties to the south of the site. Evidence of a stream is no longer visible.
- Imagery from 1995 shows the site was cleared of any vegetation and the surrounding land is undergoing earthworks.
- Google Earth imagery from 2002 shows the re-establishment of light vegetation on the site and the presence of a dirt track across the site.

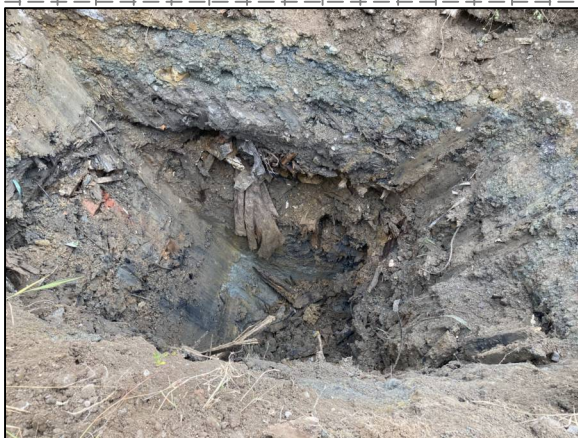
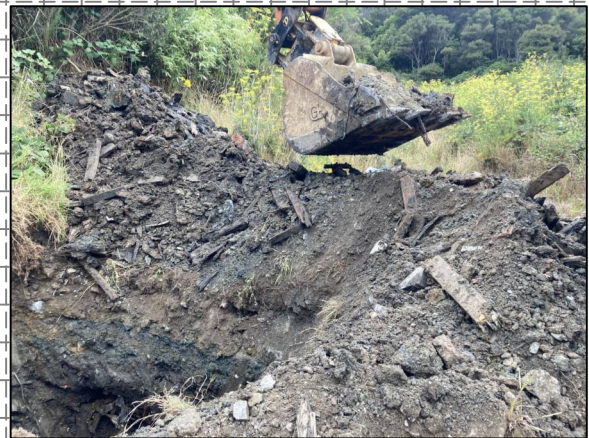
Bucket excavator met target depth at 3.1 m. at 3.1 m.  
 Scala Penetrometer met practical refusal at 1.7 m depth.  
 Standing groundwater was not encountered.

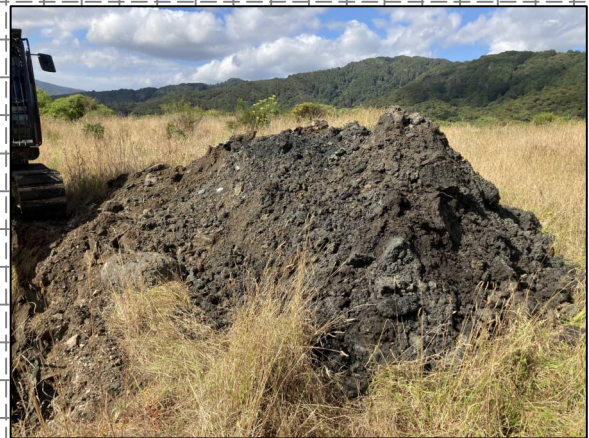
| Depth (m BGL) | Material | Excavatability<br>(Relative Scale) | USCS Symbol | DESCRIPTION | Graphic Symbol | Elevation (mRL) | Water Level | Moisture Cond. | Consistency/<br>Density Index | Shear Vane, Su<br>Peak/Remolded<br>(kPa) | Scala Penetrometer<br>Blows per 100mm |
|---|---|---|---|---|---|---|---|---|---|---|---|
| 4.5 | | | | 4.2 m - Contains lenses of PEAT; fibrous,<br>dark brown. | | | | | | | |

Bucket excavator met target depth at 5.0 m. at 5 m.  
Scala Penetrometer met practical refusal at 2.1 m depth.  
Perched groundwater encountered at 1.3 m.

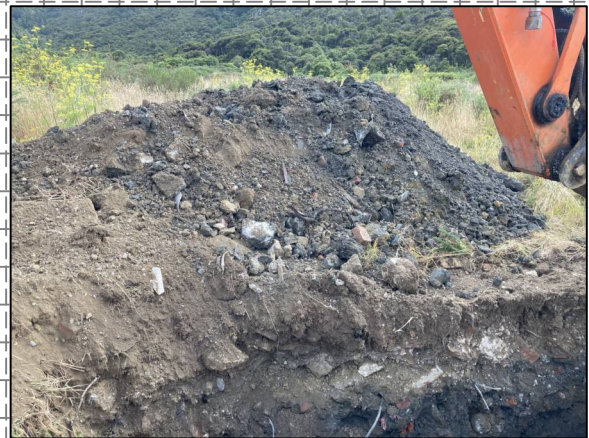
| Depth (m BGL) | Material | Excavatability<br>(Relative Scale) | USCS Symbol | DESCRIPTION | Graphic Symbol | Elevation (mRL) | Water Level | Moisture Cond. | Consistency/<br>Density Index | Shear Vane, Su<br>Peak/Remolded<br>(kPa) | Scala Penetrometer<br>Blows per 100mm |
|---|---|---|---|---|---|---|---|---|---|---|---|
| 3.0 | FILL | | ML | Gravelly SILT with minor sand; grey. Low plasticity; gravel is fine to coarse, angular to subangular, greywacke; sand is fine to coarse. Contains brick, wood, concrete and metal. [FILL] | | | | M | Loosely packed | | |

Bucket excavator met practical refusal at 3.3 m. at 3.3 m depth .  
 Scala Penetrometer met practical refusal at 0.4 m depth.  
 Standing groundwater was not encountered.

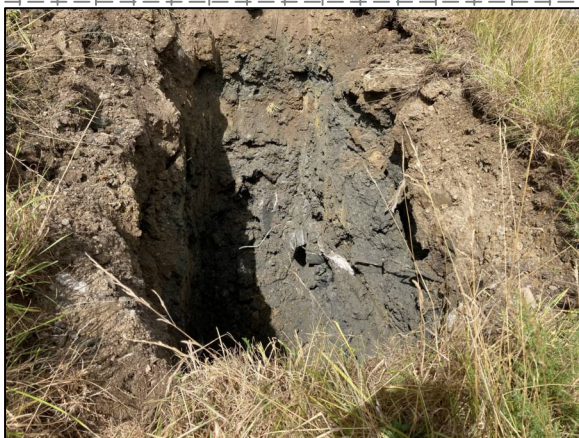
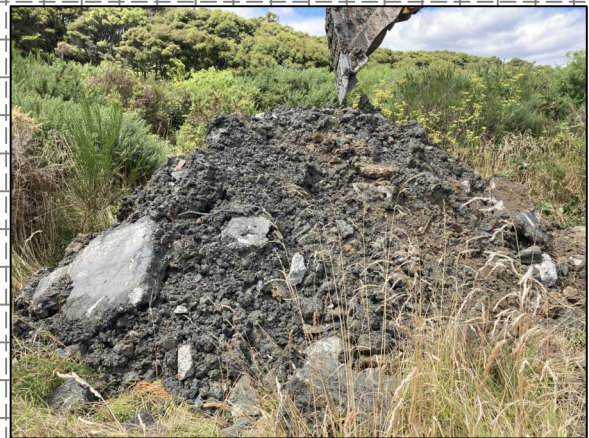
# LOG OF TEST PIT TP04

| Depth (m BGL) | Material | Excavatability<br>(Relative Scale) | USCS Symbol | DESCRIPTION | Graphic Symbol | Elevation (mRL) | Water Level | Moisture Cond. | Consistency/<br>Density Index | Shear Vane, Su<br>Peak/Remolded<br>(kPa) | Scala Penetrometer<br>Blows per 100mm |
|---|---|---|---|---|---|---|---|---|---|---|---|
| 3.0 | FILL | | GW | Fine to coarse GRAVEL with some silt, minor sand, minor cobbles and minor boulders; grey. Well graded, angular to subangular, grewacke; sand is fine to coarse; cobbles and boulders are rounded to subrounded, up to 210 mm. Contains concrete. [FILL] | | | W | Loosely packed | | | |

Bucket excavator met practical refusal at 3.8 m. at 3.8 m depth .  
 Scala Penetrometer met practical refusal at 0.4 m depth.  
 Standing groundwater was not encountered.

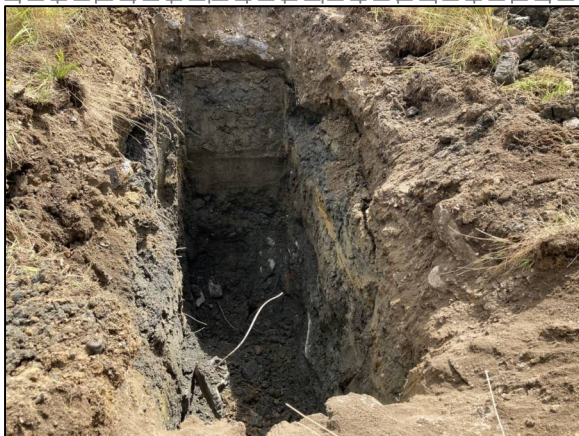
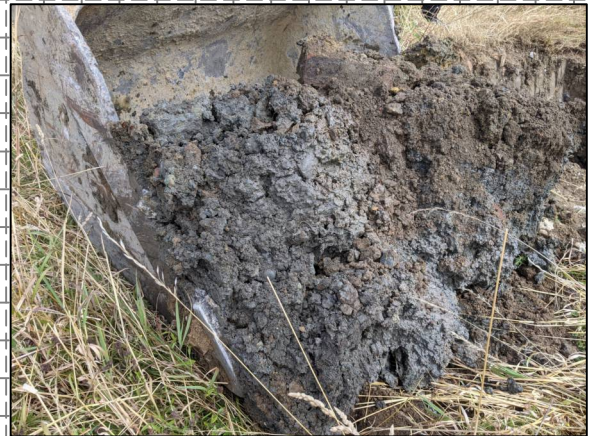
Bucket excavator met practical refusal 2.9 m. at 2.9 m depth .  
 Scala Penetrometer met practical refusal at 2.3 m depth.  
 Standing groundwater was not encountered.

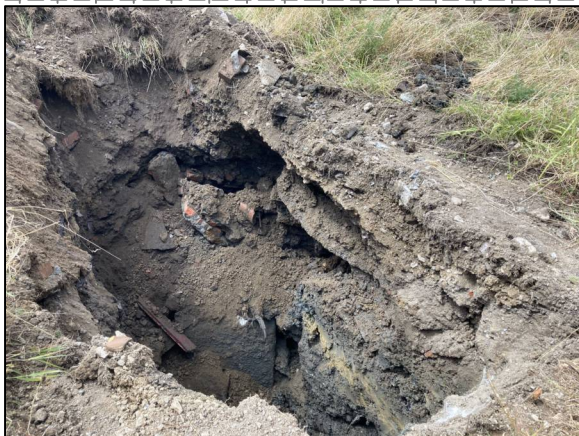
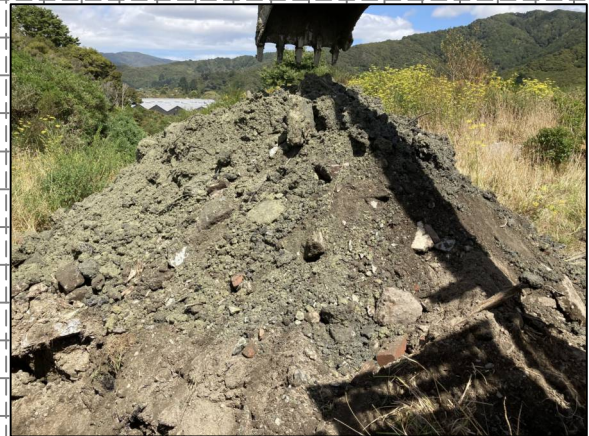
Bucket excavator met target depth at 5.0 m. at 5 m.  
 Scala Penetrometer met practical refusal at 1.5 m depth.  
 Standing groundwater was not encountered.
